ACTIVE CLEANING TECHNIQUE FOR
REMOVING CONTAMINATION FROM OPTICAL
SURFACES IN SPACE

Quarterly Progress Report No. 8

Boeing Aerospace Company
Research and Engineering Division
Seattle, Washington 98124

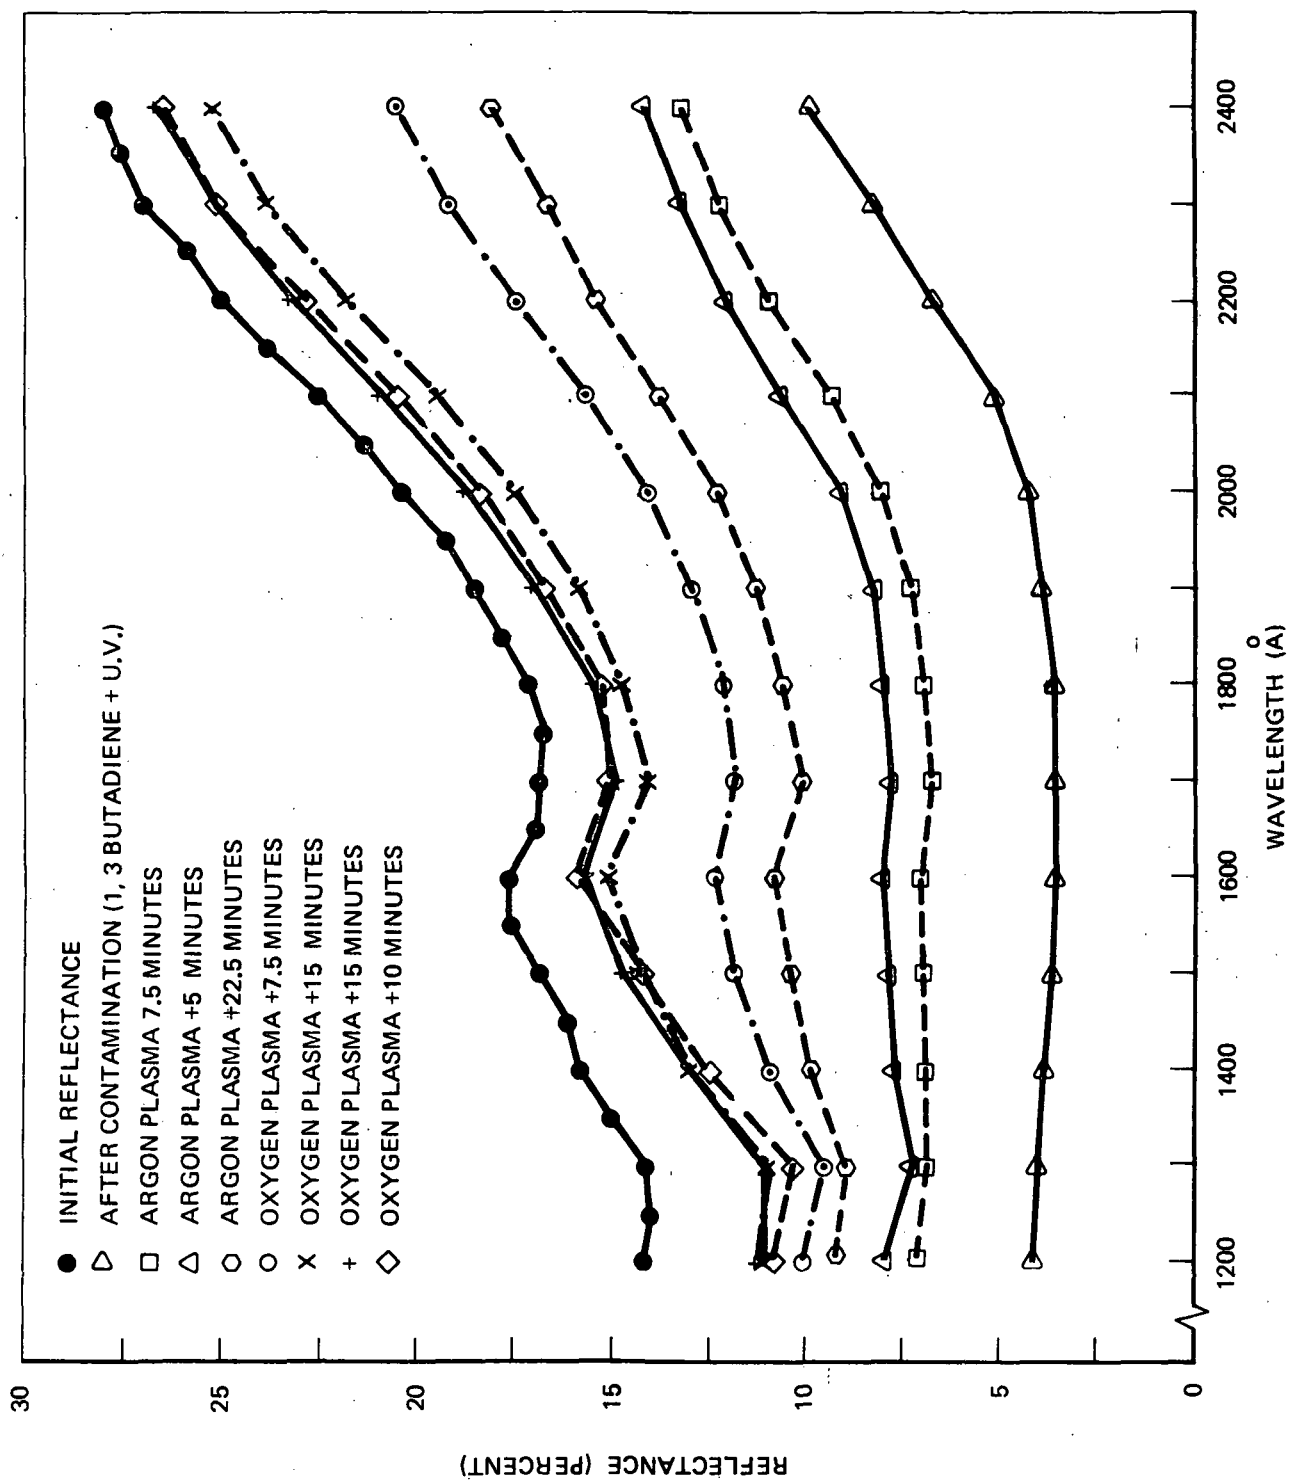
Figure 1: REFLECTANCE DATA FOR GOLD COATED MIRROR Au6

Table 1 gives the 'log of events' for gold coated mirror sample Au6. Figures 1 and 2 show the reflectance data for this sample. The primary objective of this experiment was to determine the effect of exposure to an argon plasma. Figure 1 shows that the argon plasma removes the contaminant film. Instead of continuing the argon plasma exposures it was decided to see if an oxygen plasma would clean more rapidly. The data in Figure 1 do not indicate any apparent differences in cleaning rate. Since the reflectance was not completely restored the question is raised as to whether or not the order of exposure (in this case argon first and then oxygen) affects the contaminant cleaning. The tests of this sample also show that a short term (one hour) exposure to ambient air does not change the contaminant film effects on the U.V. reflectance.

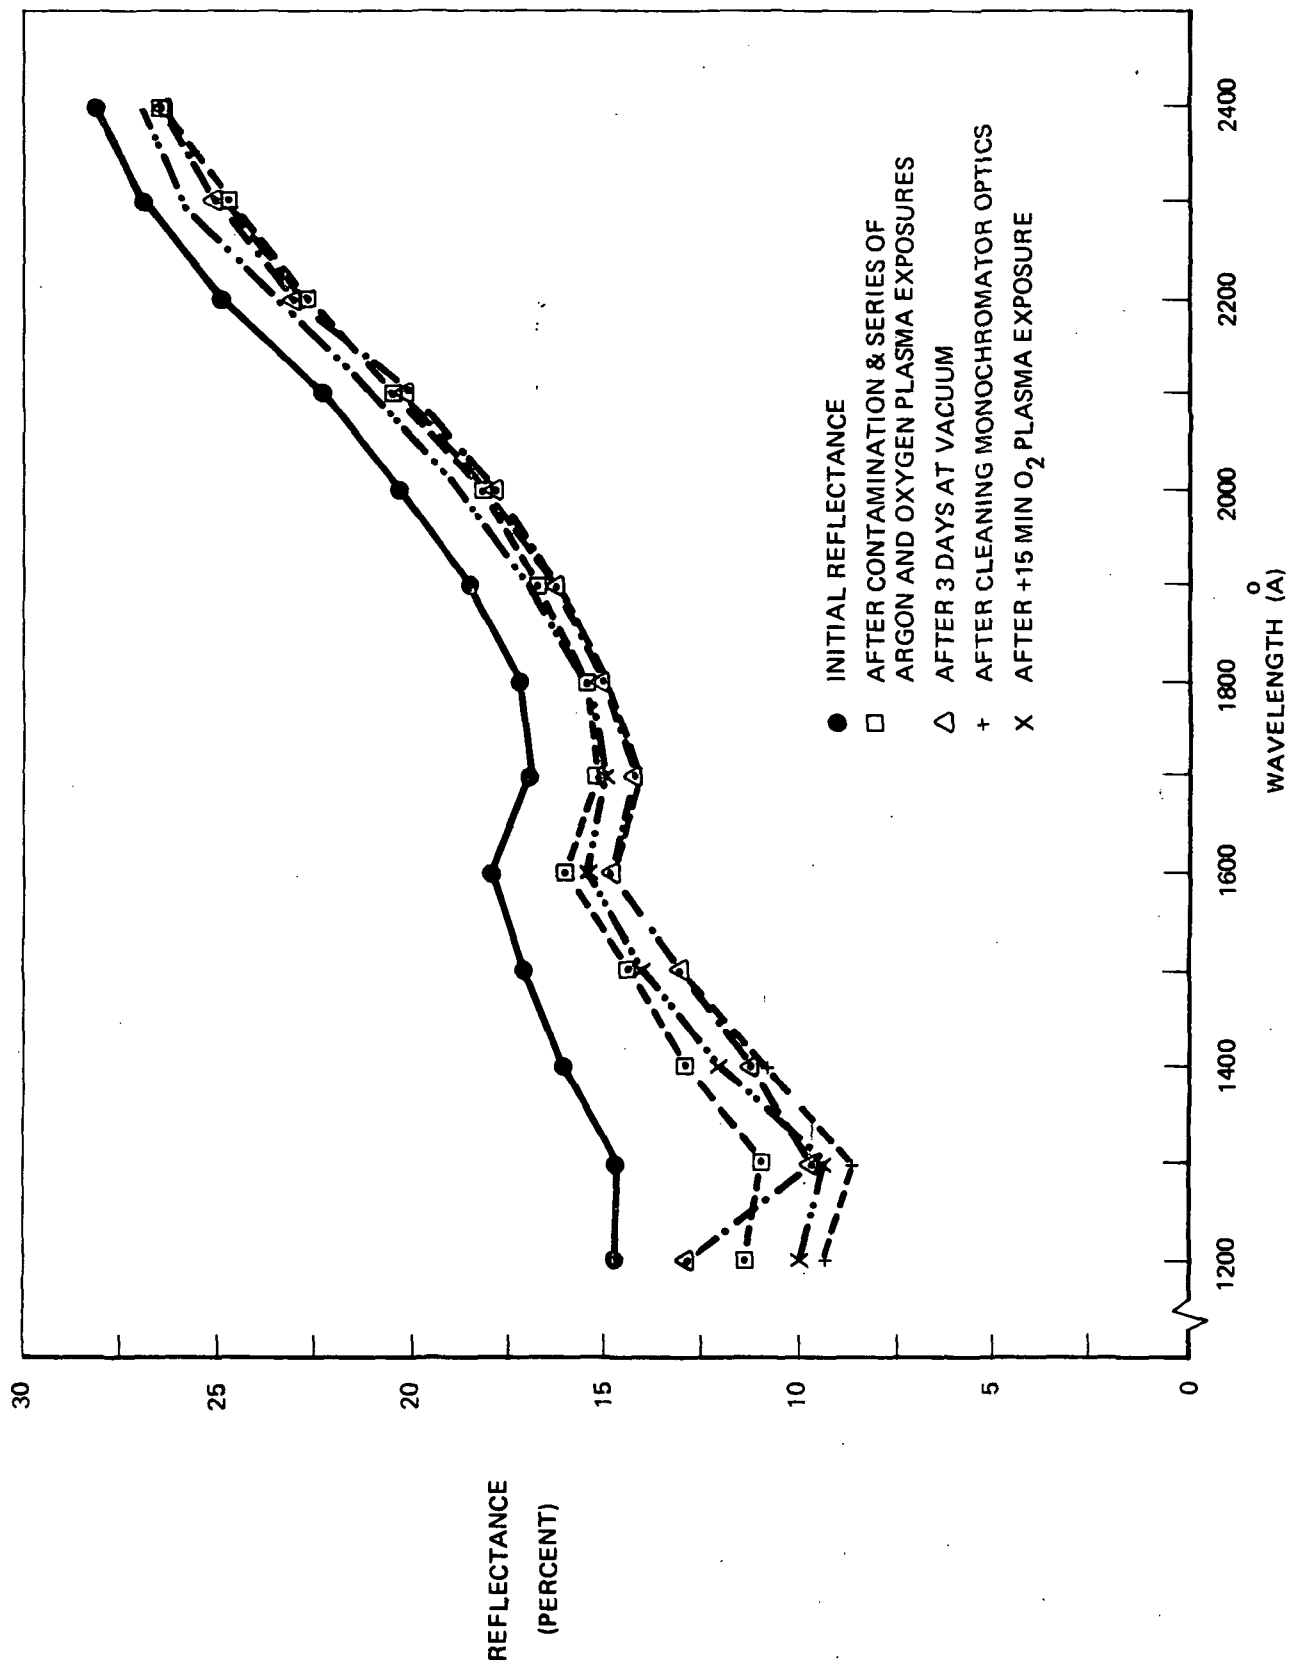
Figure 2: REFLECTANCE DATA FOR GOLD COATED MIRROR Au6

Also shown in these tests is a slight degradation of the U.V. reflectance during an extended period (3 days) under vacuum (see Figure 2). The data in Figure 2 also show that the degradation of the monochromator optics influences the reflectance data measurements in the 1200 to 1400 Å wavelength region.

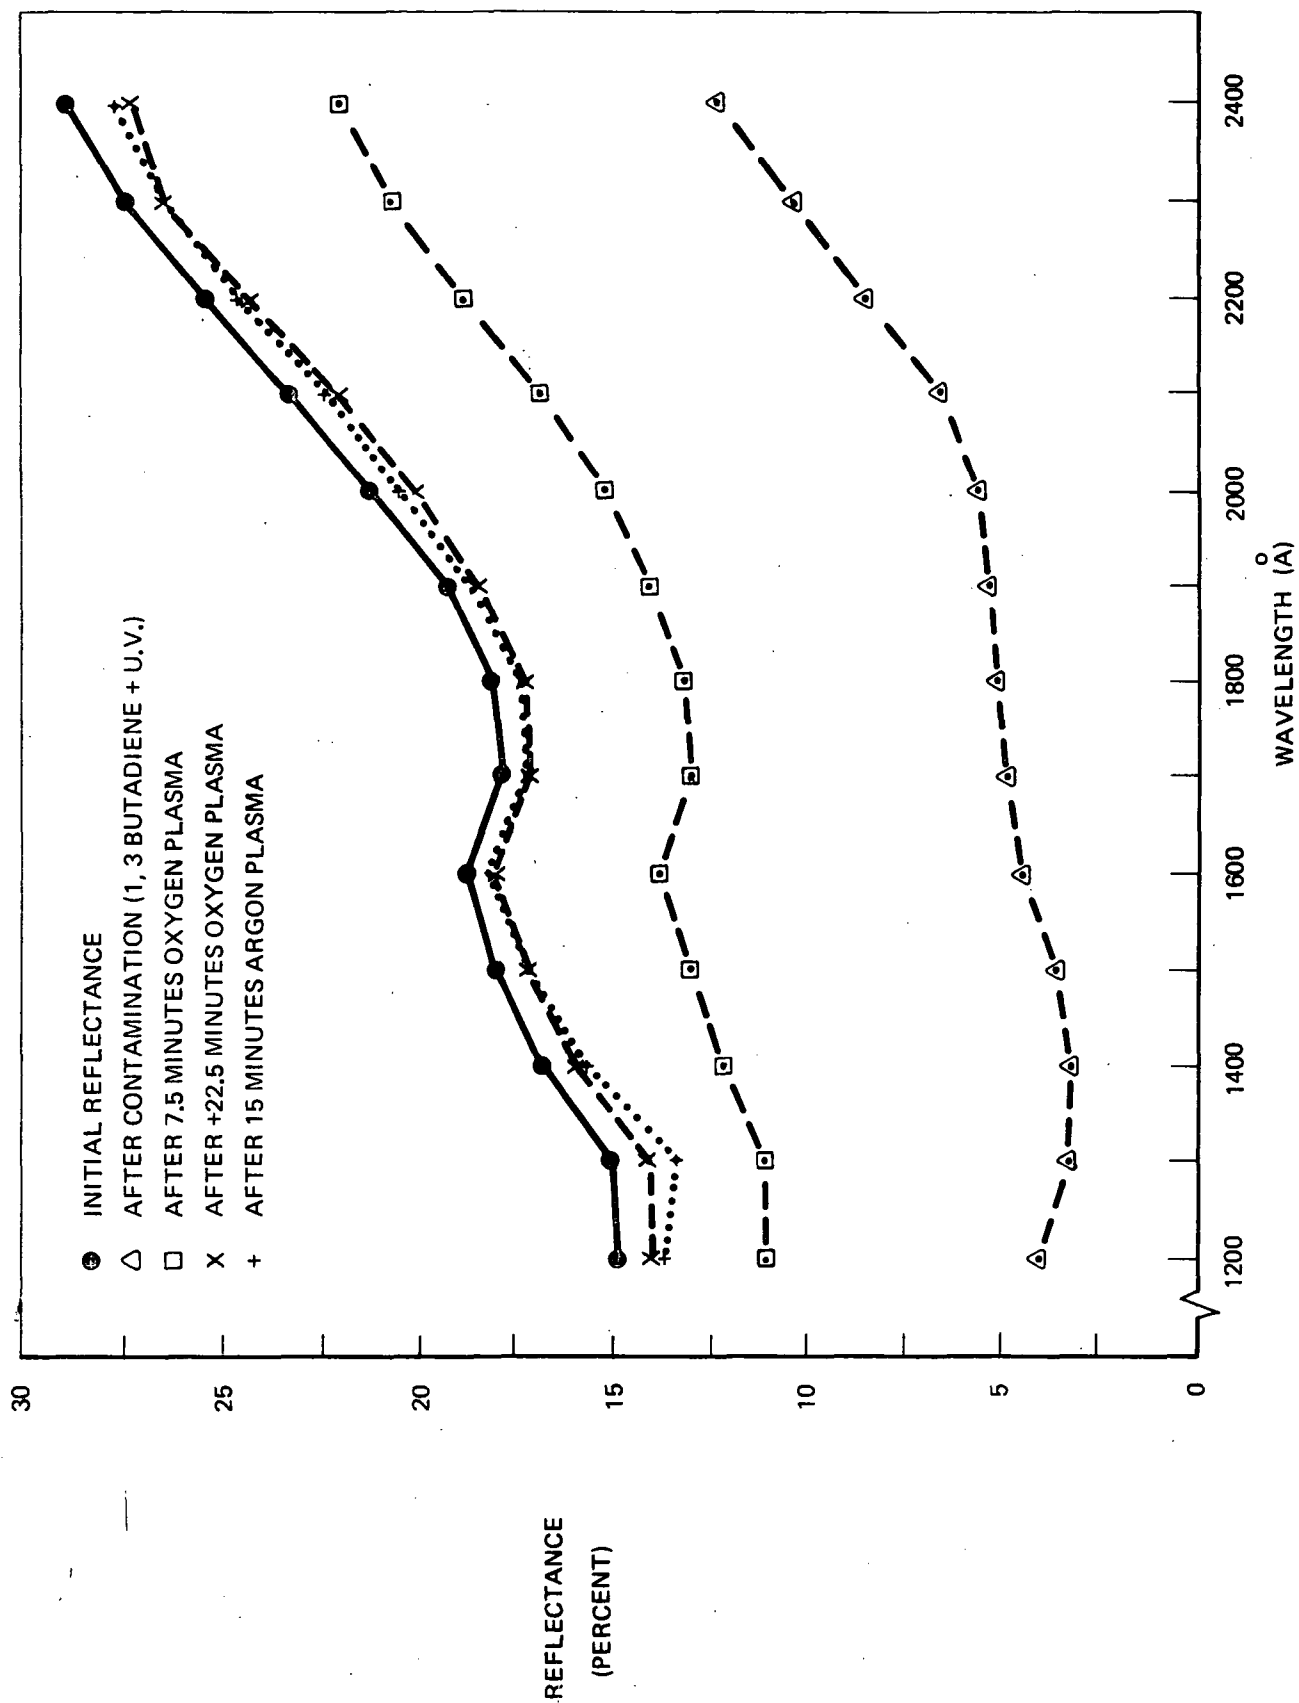
Figure 3: REFLECTANCE DATA FOR GOLD COATED MIRROR Au7

In order to see if the order of plasma exposure (argon or oxygen first) affects the contaminant film cleaning, experiments were conducted using a second gold coated mirror (Au7). Table 2 gives the 'log of events' and Figures 3-5 show the reflectance data for sample Au7. Figure 3 shows that the U.V. reflectance was nearly restored using two oxygen plasma exposures and that an additional exposure using an argon plasma had little effect on the reflectance. Since the U.V. reflectance of Au7 was more completely restored using an oxygen plasma than was that of Au6 using first argon and then oxygen plasmas, Au7 was recontaminated to see if argon would be as effective as oxygen in plasma cleaning. Figure 4 shows that a 15 minute argon plasma exposure restored the U.V. reflectance to that prior to recontamination. These data indicate that there is little difference between argon and oxygen plasma cleaning. If the cleaning phenomena is, as has been thought, due to the chemical reaction between the plasma and the contaminant film resulting in volatile products, then it seems reasonable to expect much more effective cleaning with oxygen than with argon. Since this does not occur, the cleaning phenomena must be related to the interaction of excited atoms in the plasma with the contaminant film and/or ion sputtering of the contaminant film. Similar conclusions were reached in a recent experimental investigation (Reference 9) which showed that the presence of atomic oxygen was not sufficient for cleaning contaminant films. Figure 4 also shows that the U.V. reflectance of the sample degraded after

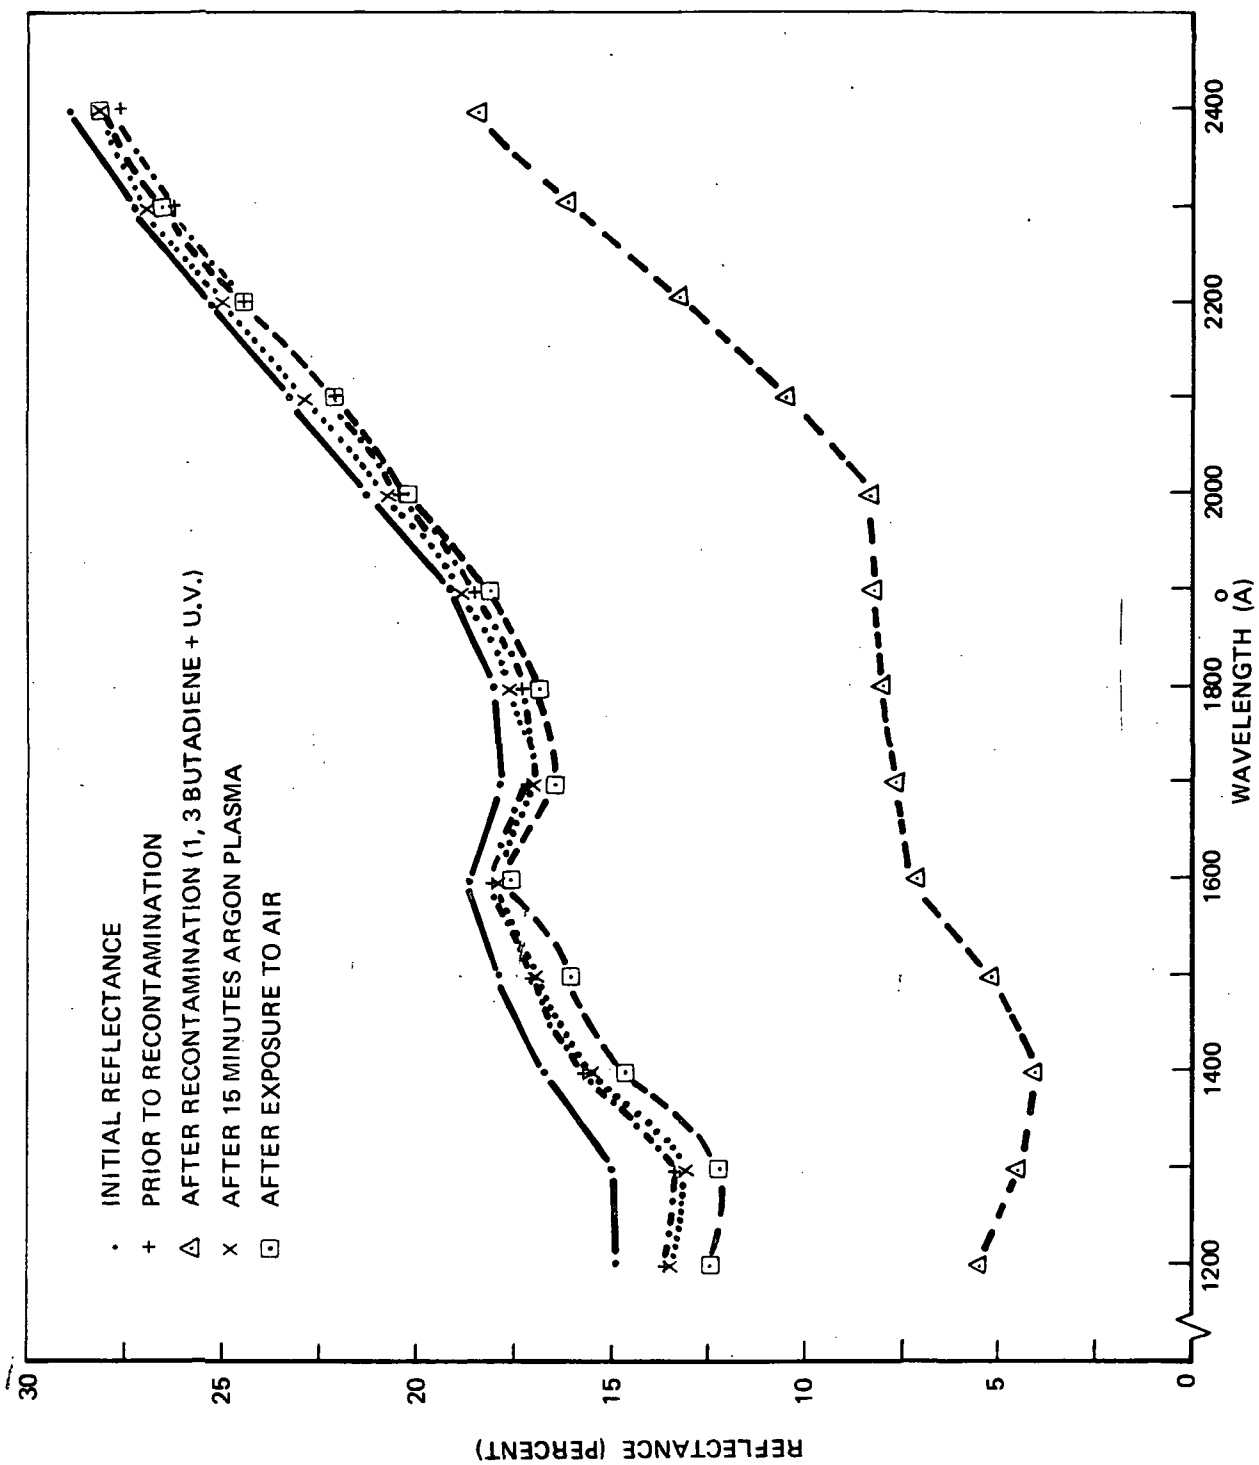
Figure 4: REFLECTANCE DATA FOR GOLD COATED MIRROR Au7

it has been exposed to air while the vacuum chamber quartz U.V. window was being cleaned. This degradation might have been due to contamination from the solvents (ethanol and methylethylketone) used in cleaning the window.

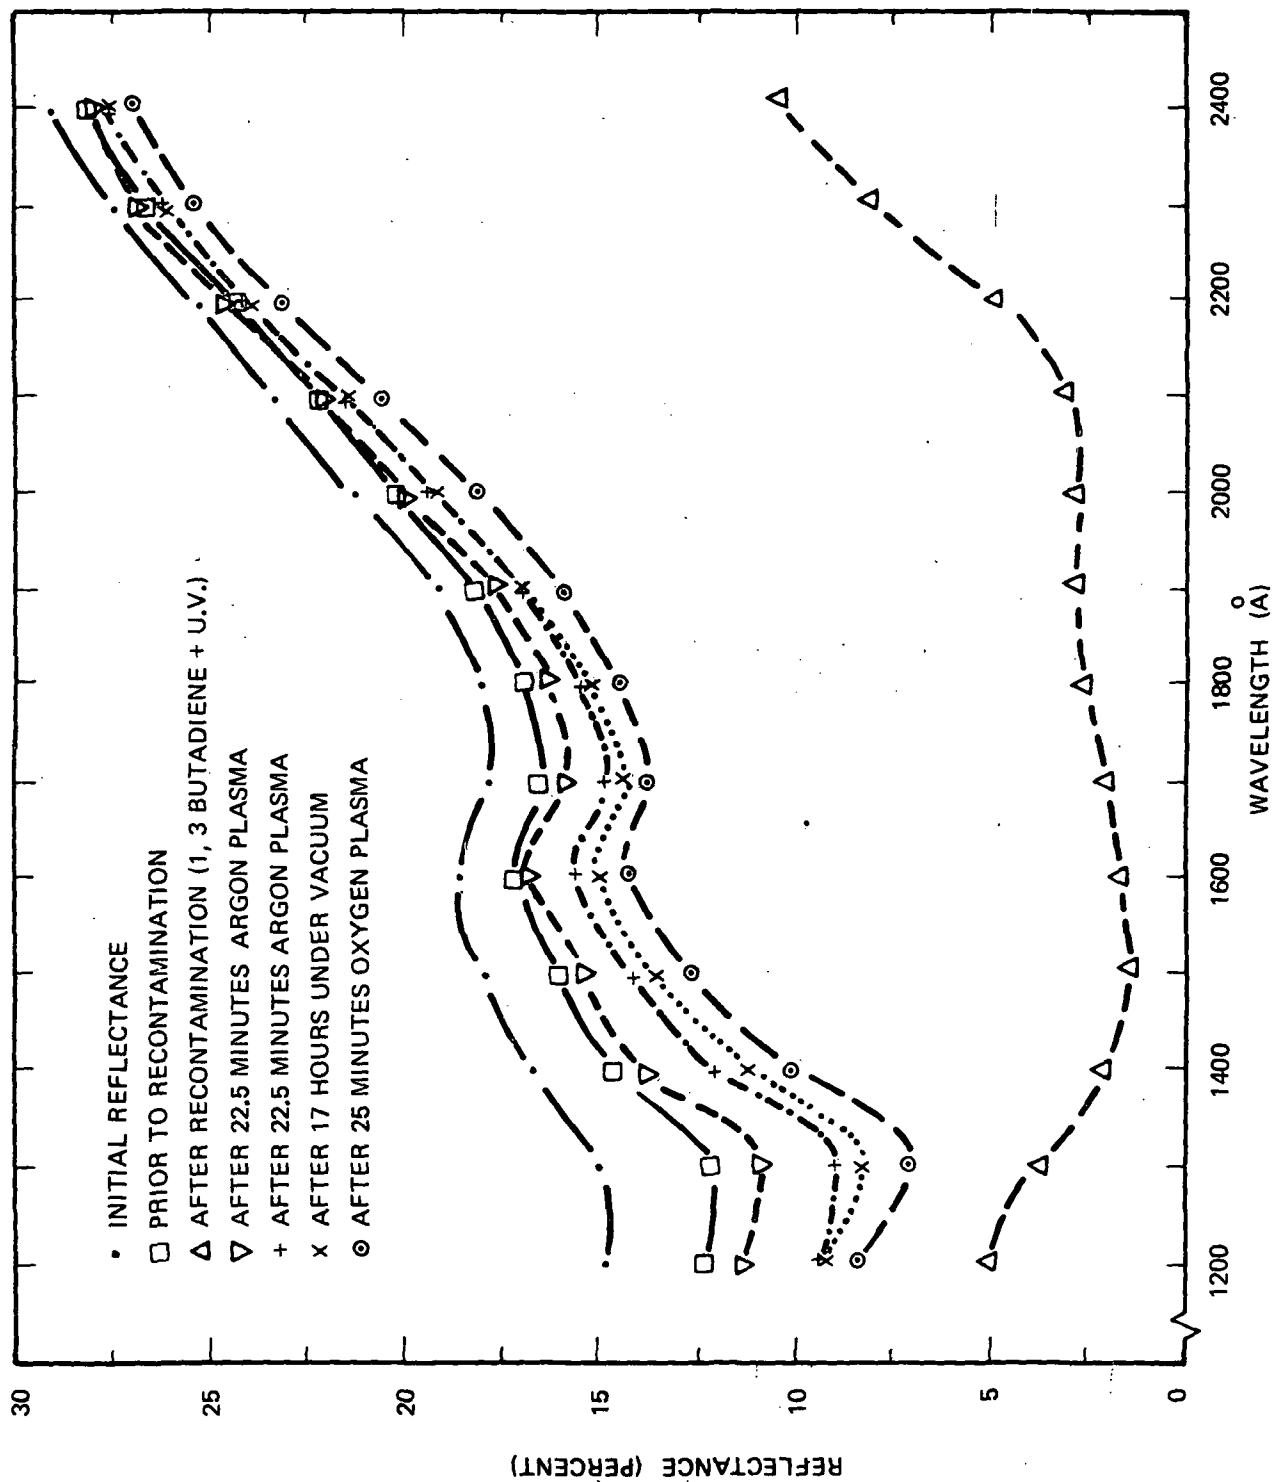
Figure 5: REFLECTANCE DATA FOR GOLD COATED MIRROR Au7

Following the argon plasma cleaning, sample Au7 was recontaminated and exposed to ambient air for 20 hours. This ambient air exposure had no measurable effect on the degraded U.V. reflectance of the sample. Figure 5 shows that a 22.5 minute argon plasma exposure nearly restored the U.V. reflectance to that prior to recontamination. However an additional 22.5 minute argon plasma exposure produced degradation in the reflectance. Leaving the sample exposed to vacuum for 17 hours resulted in slight further reflectance degradation. This result is consistent with that observed for sample Au6. Apparently contaminants from the closed-off vacuum system deposit on the cooled sample to some degree. Figure 5 also shows that an additional 25 minute exposure to an oxygen plasma produced further reflectance degradation. This along with the results of the previous argon plasma exposure indicates 'over cleaning' of the sample.

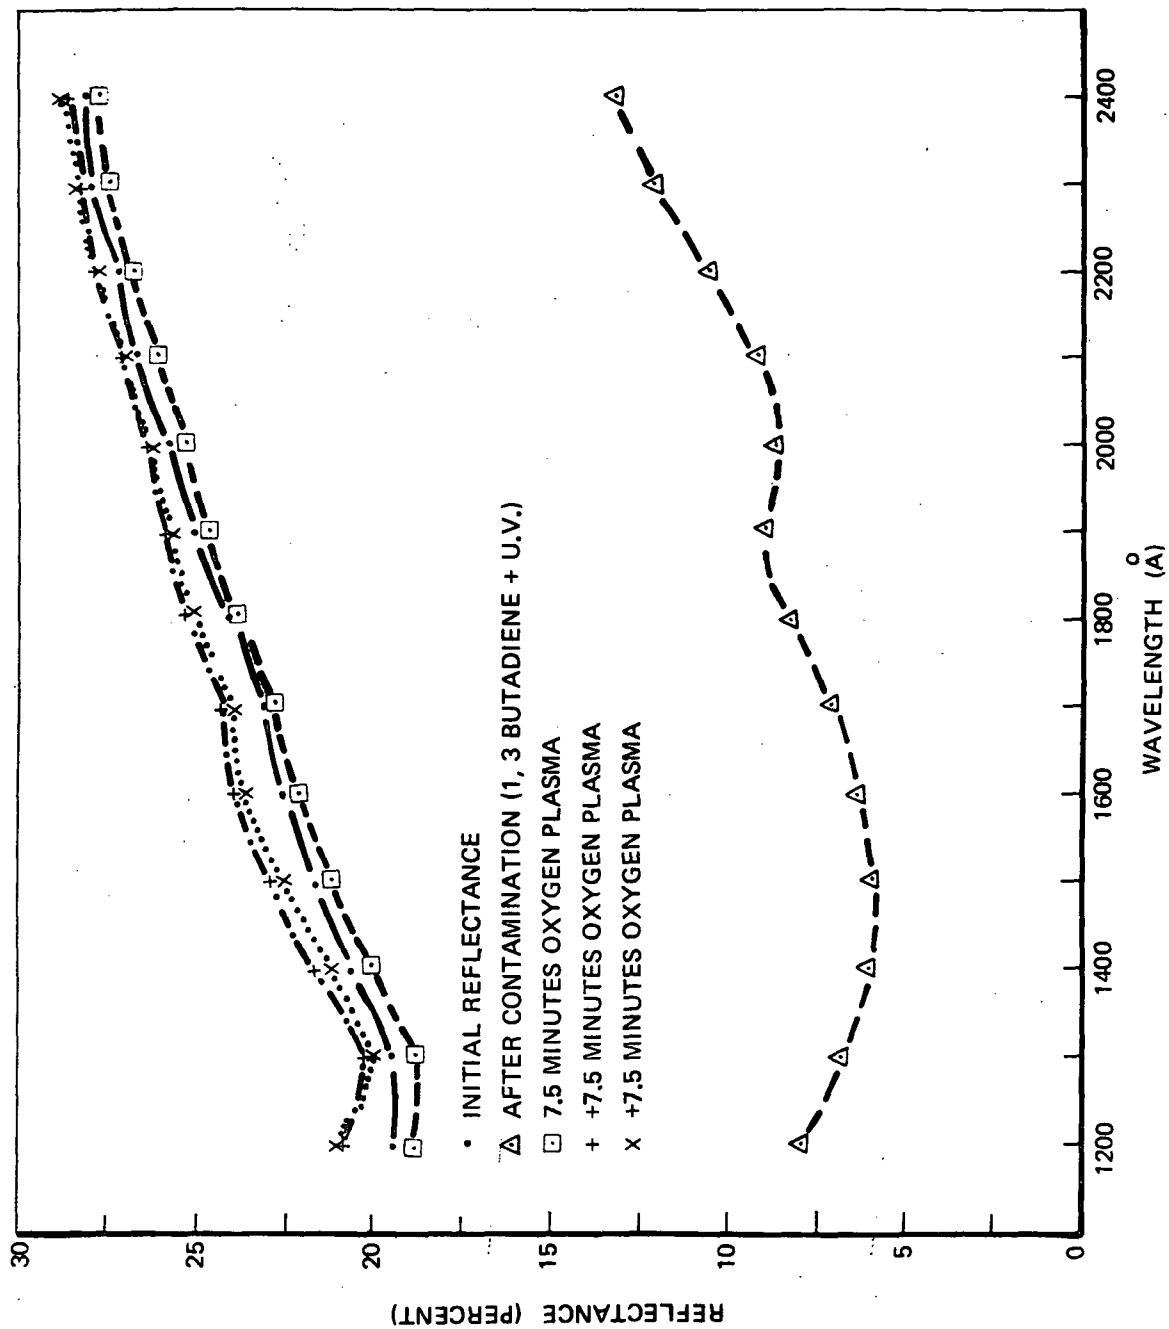
Figure 6: REFLECTANCE DATA FOR PLATINUM COATED MIRROR Pt 14

Table 3 gives the 'log of events' for the experiment using platinum coated mirror Pt 14. The reflectance data for this sample are shown in Figures 6 and 7. Figure 6 shows that the degradation, produced by the butadiene contaminant film, was almost eliminated with a single 7.5 minute oxygen plasma exposure. A second exposure increased the reflectance beyond that prior to contamination. A third exposure produced little effect. The sample was then contaminated again and left under vacuum, with the vacuum system closed-off, for 65 hours. Figure 7 shows the amount of degradation still present after this extended period under vacuum. The degree of degradation is less than that shown in Figure 6. Some of the contaminant film may have been removed by the extended period under vacuum, however, it should be noted that the initial contamination

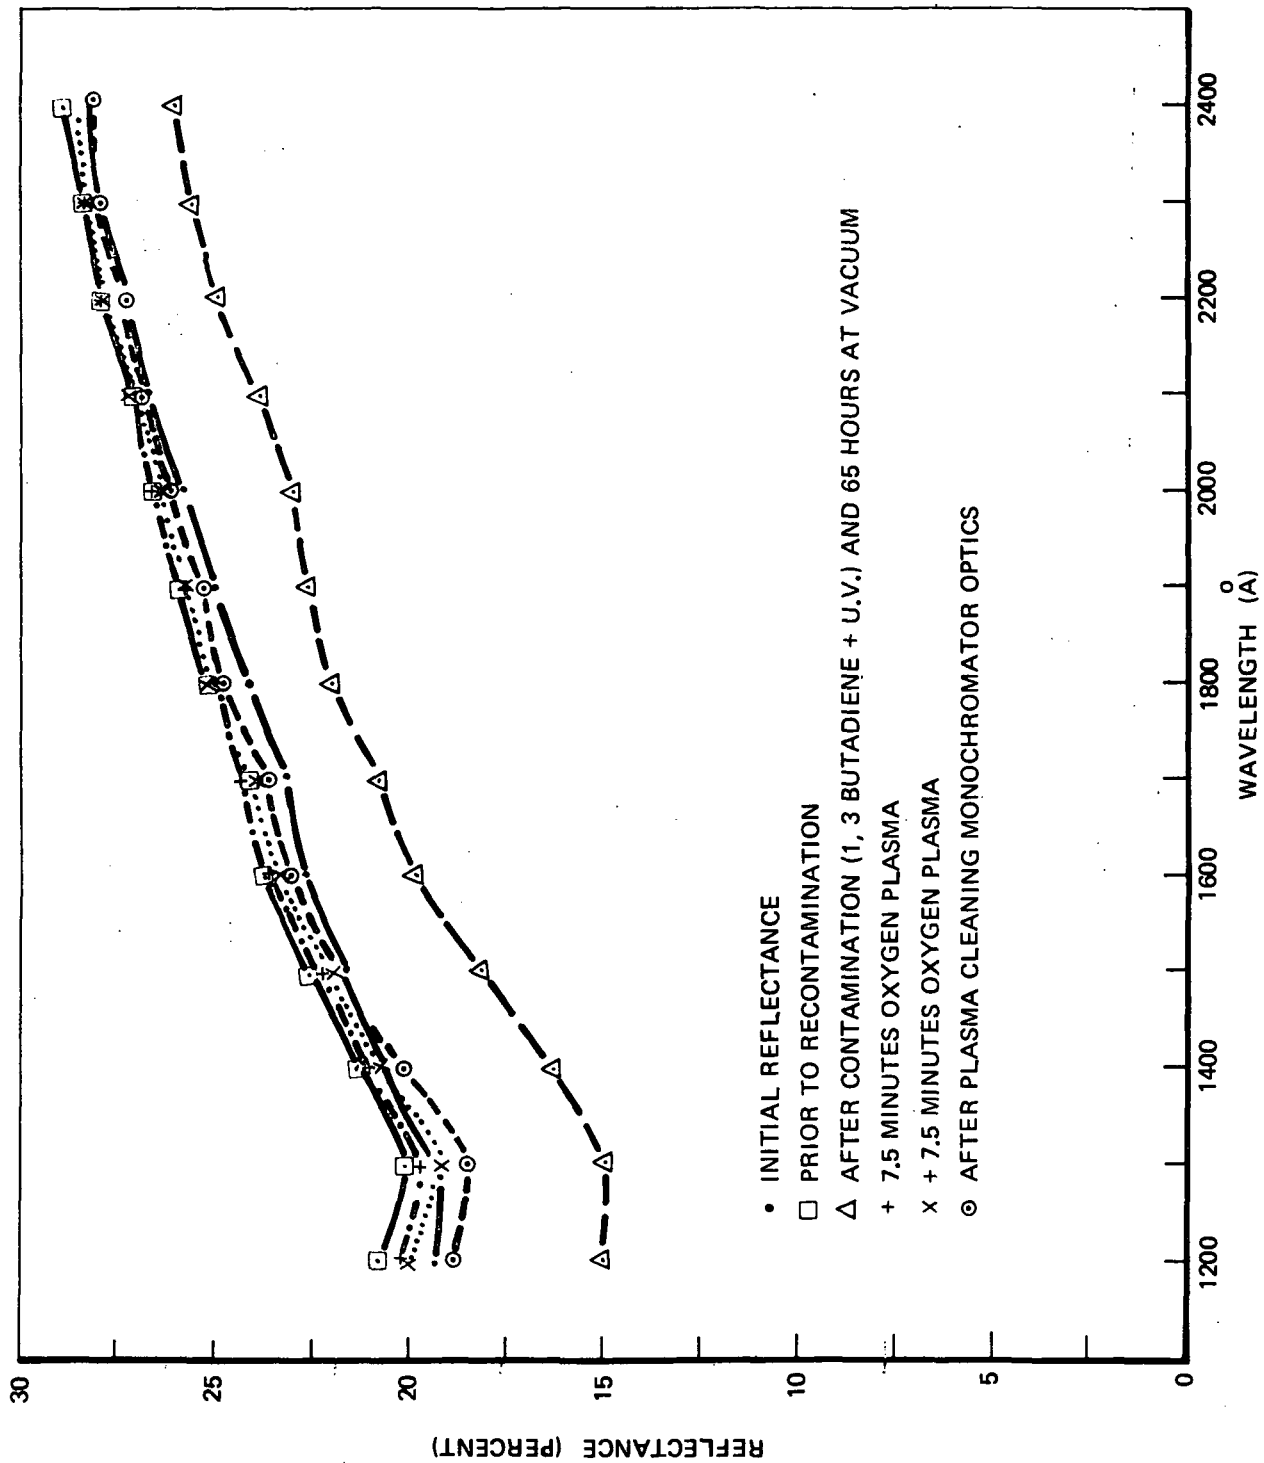
Figure 7: REFLECTANCE DATA FOR PLATINUM COATED MIRROR Pt 14

produced about six times the amount of contaminant film that was produced in the recontamination. Consequently the primary reason for the differences in degree of degradation is probably the amount of contaminant film deposition rather than the effects of the extended vacuum exposure. The reflectance (prior to recontamination) was essentially restored with a 7.5 minute oxygen plasma exposure. A second exposure produced little change in the reflectance. However, after plasma cleaning the monochromator optics, a remeasurement of the reflectance showed slight degradation in the 1200-1500Å wavelength region. This again indicates that the degradation of the monochromator optics influences the reflectance measurements in the shorter wavelength region.

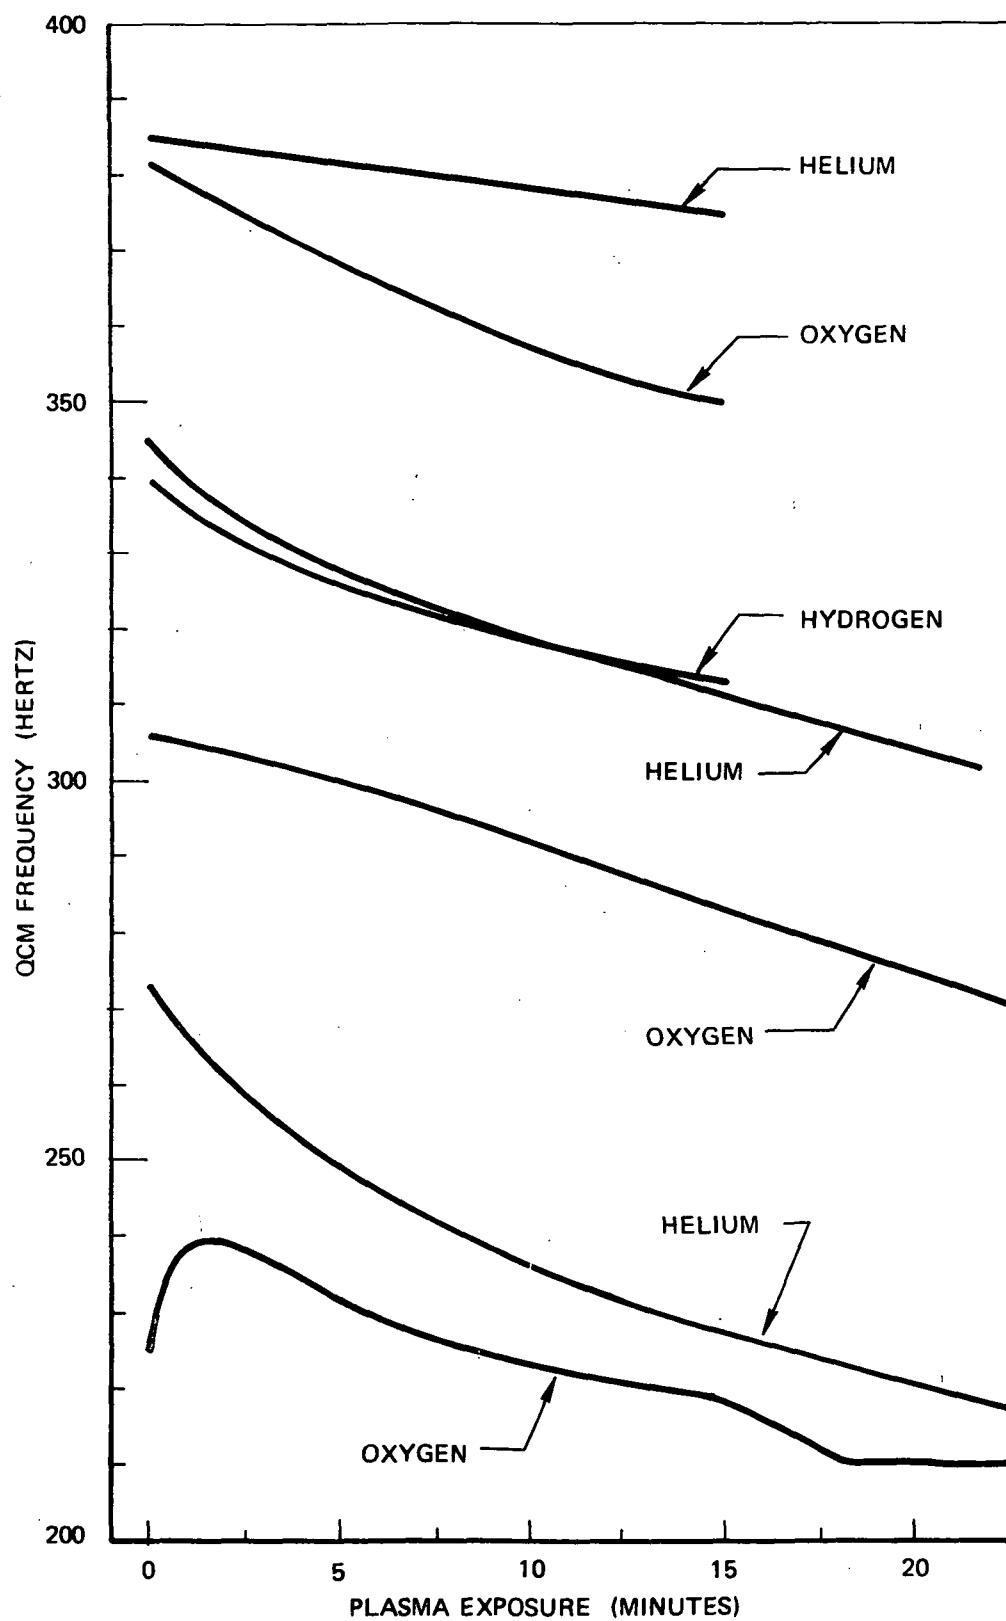
Figure 8: PLASMA CLEANING OF CARBON COATED QCM

Figure 8 shows the effects of plasma exposure on the frequency of the QCM. A reduction in the QCM frequency indicates a removal of mass from the crystal (removal of 1 microgram/cm² changes the frequency by about 50 Hertz). All plasma exposures used the 'ignited plume' mode of operation. The initial series of tests used helium, oxygen and hydrogen plasmas. Figure 8 (top three curves) indicates that oxygen and hydrogen are about equally effective in removing carbon. Helium appeared to be less effective. In order to verify this result a second series of tests were made using helium and oxygen. Figure 8 (bottom four curves) indicates that helium is as effective as oxygen in

removing the carbon. It should be noted that the final plasma exposure, using oxygen, removed the remaining carbon from the QCM. These data show that helium, oxygen and hydrogen plasmas are equally effective in removing carbon. The apparently less effective cleaning during the initial exposure, using helium, may just be an anomaly or may have something to do with it being the first exposure to a plasma. These results add further evidence that normal chemical reaction, between plasma and surface resulting in volatile products, is not the basic cleaning process.

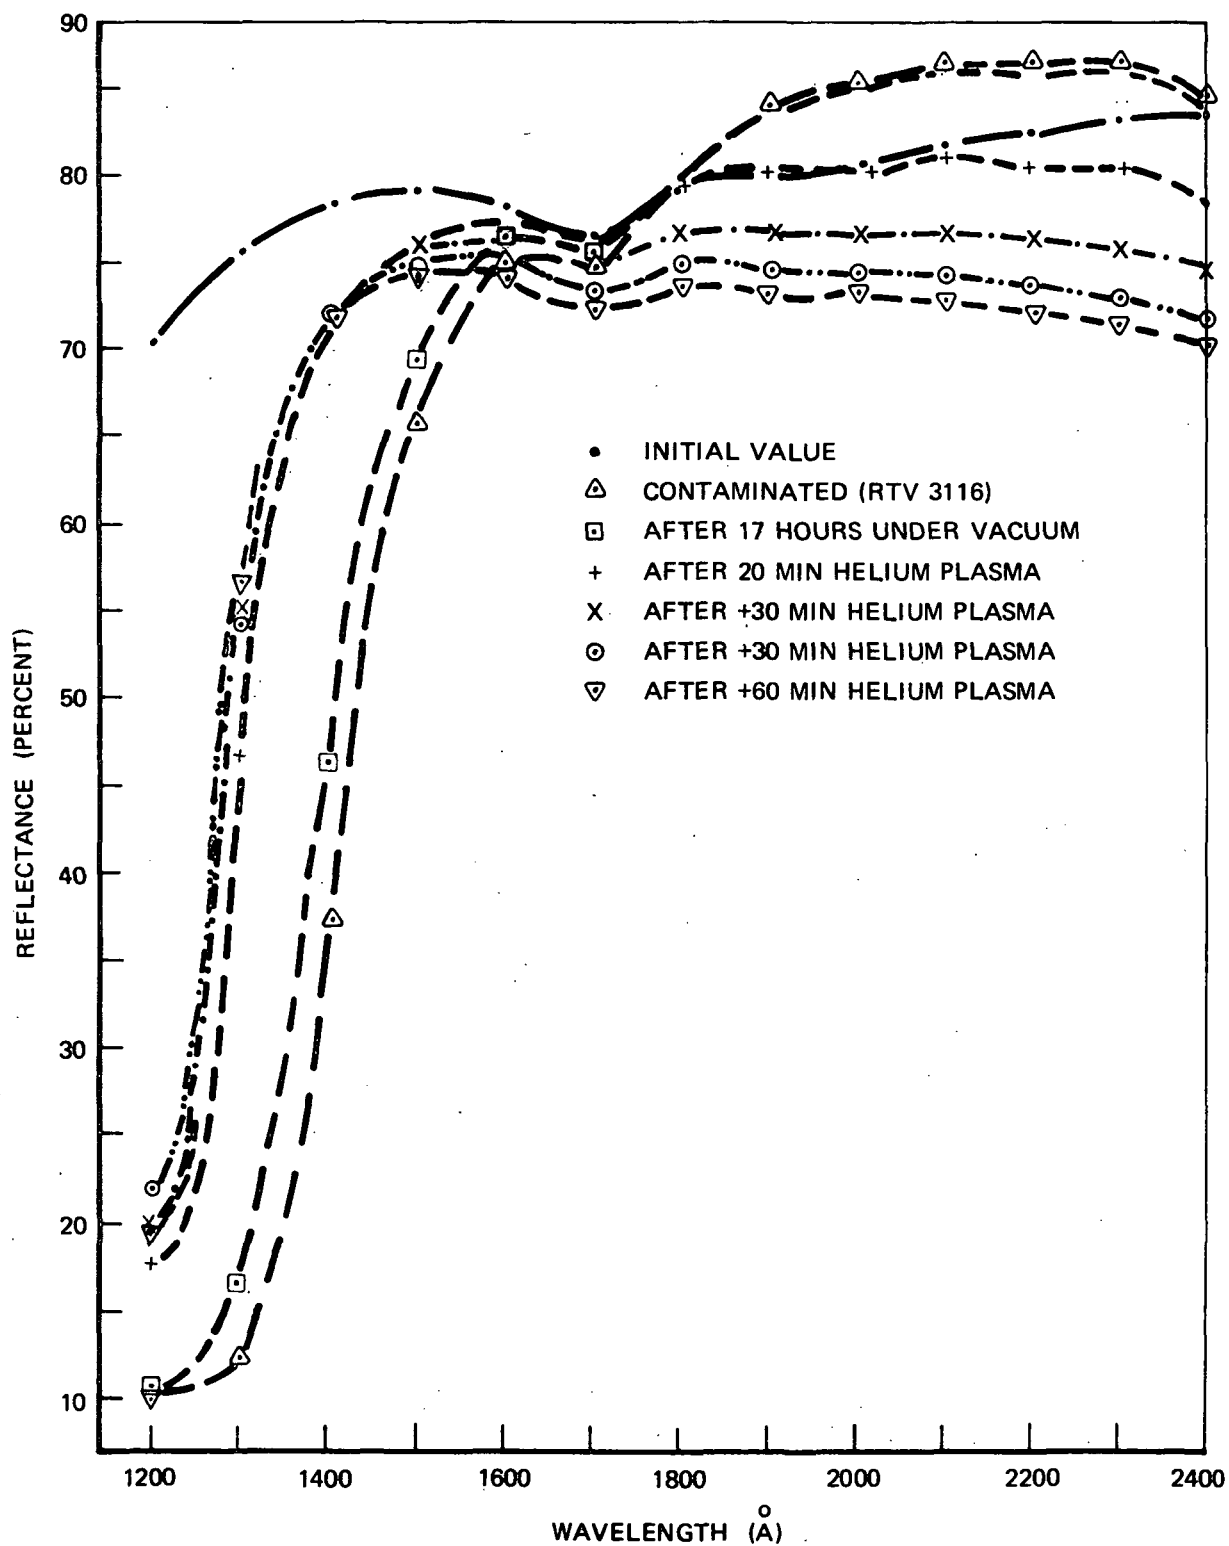
Figure 9: REFLECTANCE DATA FOR MgF_2/Al MIRROR MgF 113

The first MgF_2/Al mirror (MgF113) was exposed to the outgas products of RTV3116 for 24 minutes. The QCM response indicated a contaminant film deposition of about $2 \times 10^{-6} \text{ gm/cm}^2$. The U.V. reflectance of the sample was severely degraded in the 1200-1400 Å wavelength region and was increased in the 1800-2400 Å wavelength region (Figure 9 shows the reflectance data for sample MgF113). As shown in Figure 9, some of the contaminant film appears to have evaporated during a 17 hour period under vacuum. The sample was then subjected to a series of helium

plasma exposures (the first for 20 minutes then four of 30 minutes each). These exposures increased the reflectance at the shorter wavelengths, however, that at the longer wavelengths was decreased (see Figure 9). The restoration at the shorter wavelengths appeared to be limited, whereas, the degradation at the longer wavelengths appeared to be progressive. A subsequent 15 minute exposure to an oxygen plasma (results not shown in Figure 9) resulted in very little change in reflectance except for a slight degradation in the 1200-1400Å wavelength region.

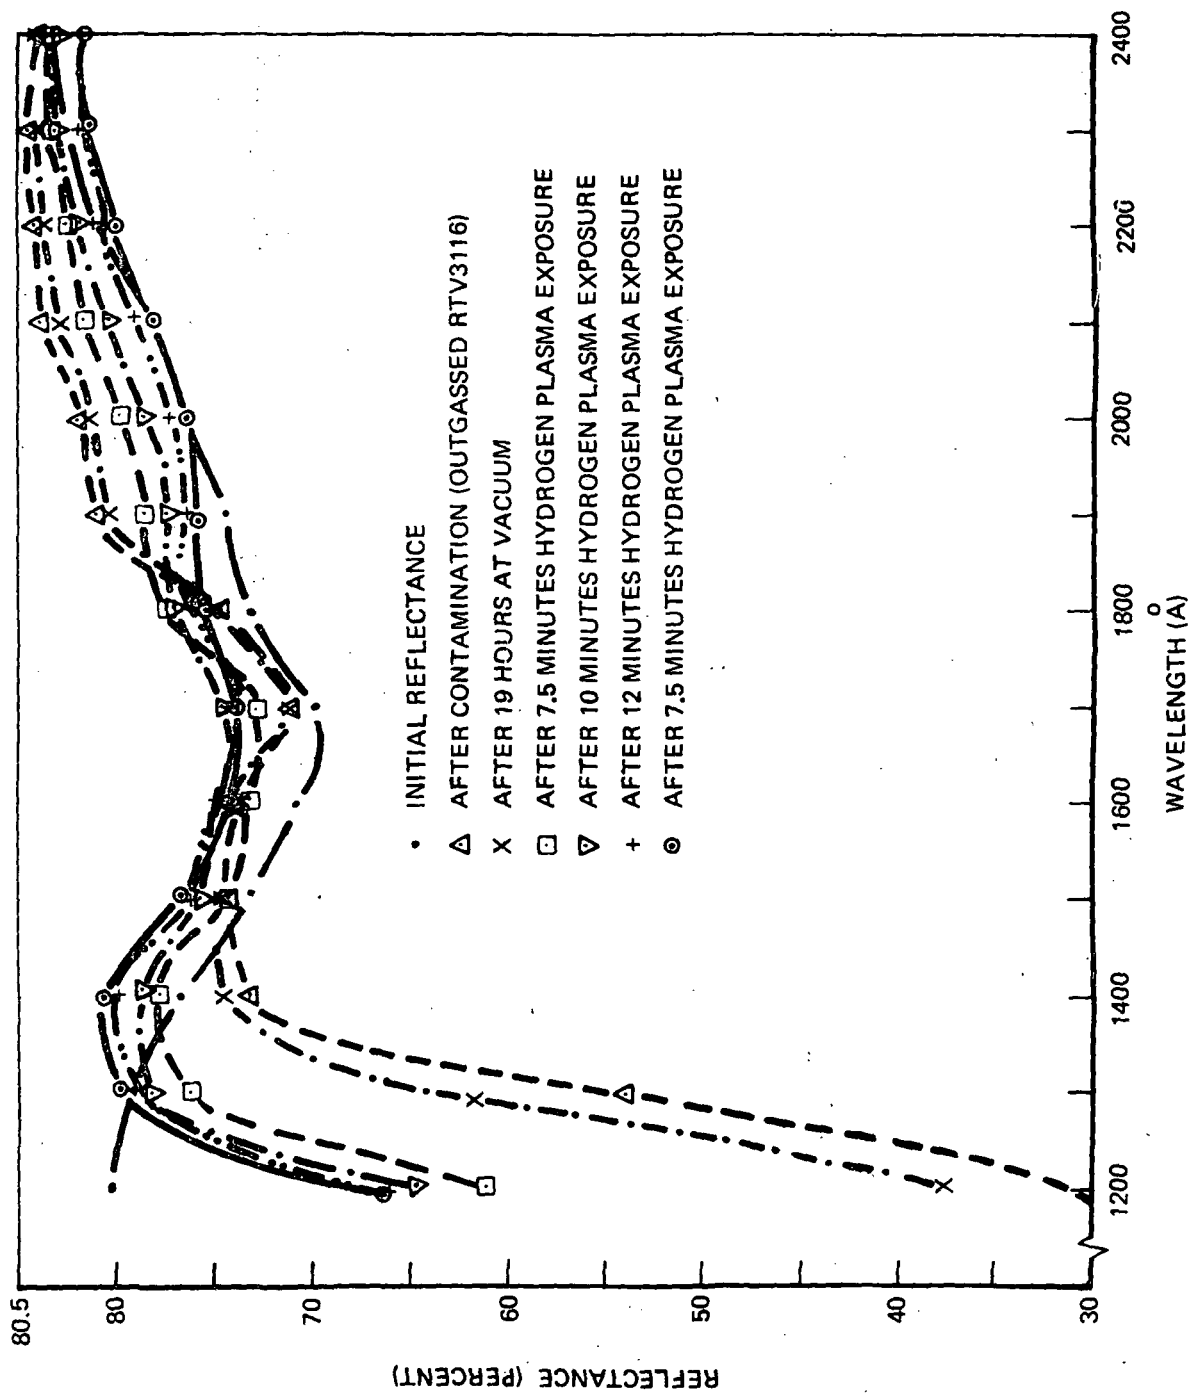
Figure 10: REFLECTANCE DATA FOR MgF_2/Al MIRROR MgF_{114}

A second MgF_2/Al mirror (MgF114) was exposed to the outgas products of RTV3116 for 30 minutes. The QCM response indicated a contaminant film deposition of about $1.5 \times 10^{-6} \text{ gm/cm}^2$. The effects of the contaminant film on the U.V. reflectance are similar to those observed for sample MgF113 (see Figure 10). The data in Figure 10 also indicate that some of contaminant film evaporated, as before, during a 19 hour exposure to vacuum. This sample was subjected to a series of hydrogen plasma exposures of 7.5, 10, 12 and 7.5 minutes. As with the helium plasma exposures of MgF113, the hydrogen plasma exposures increased the reflectance of MgF114 at the shorter wavelengths and decreased it at the longer wavelengths. However the hydrogen plasma produces more restoration at the shorter wavelengths and less degradation at the longer wavelengths. Subsequent to this series of plasma exposures the sample was left under vacuum for 18 hours and then subjected to three additional plasma exposures, (12 minutes using hydrogen, 9 minutes using oxygen and 7.5 minutes using helium). Figure 11 shows the reflectance data for these cases. The hydrogen plasma exposure resulted in a slight improvement at the shorter wavelengths and slight degradation at the longer wavelengths. The oxygen plasma exposure resulted in slight further degradation. The helium plasma exposure produced a significant further degradation of the reflectance.
